# Naga-Waukee Park Slope Restoration Project

Waukesha County Department of Parks and Land Use

2016 Stormwater Workshop

By Alan Barrows, Sr. Conservation Specialist

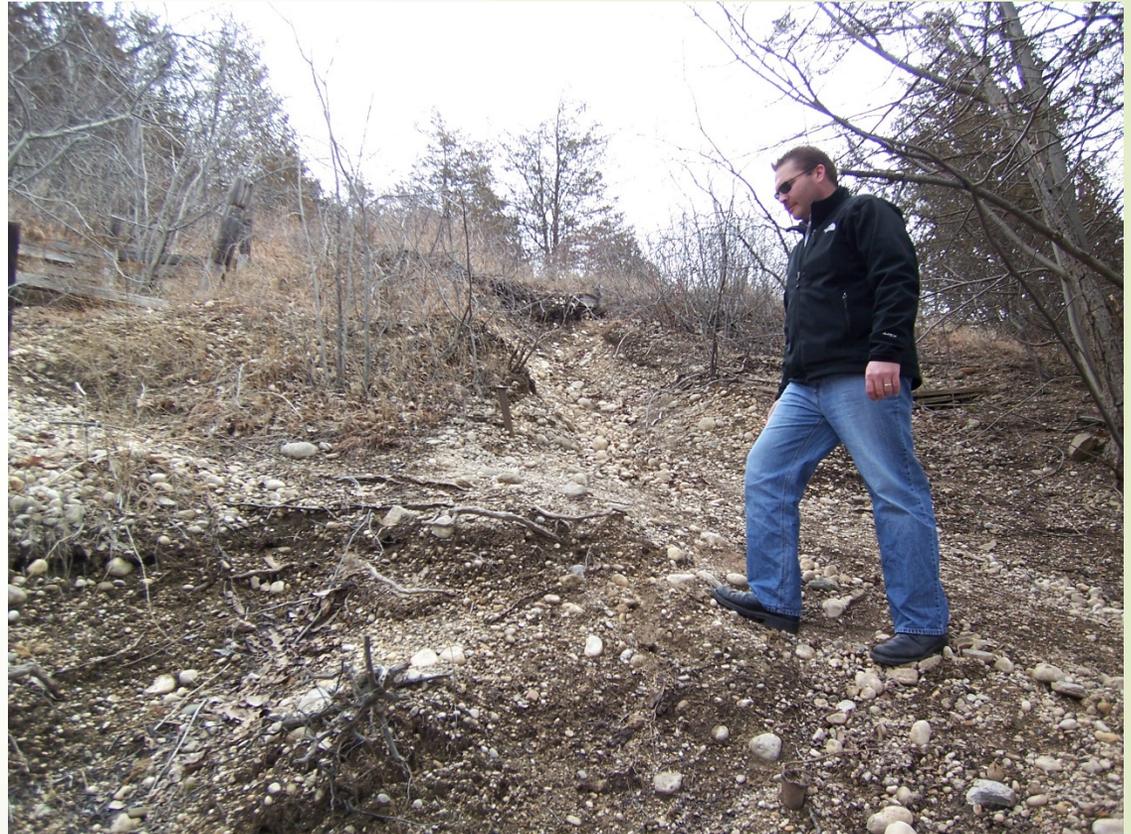
- Project area had been used for “un-programmed recreation” for decades.
- Soil erosion caused largely by human foot traffic.
- Efforts to prevent further slope degradation had been unsuccessful.
- Land Resources Division was contacted for assistance in 2010.

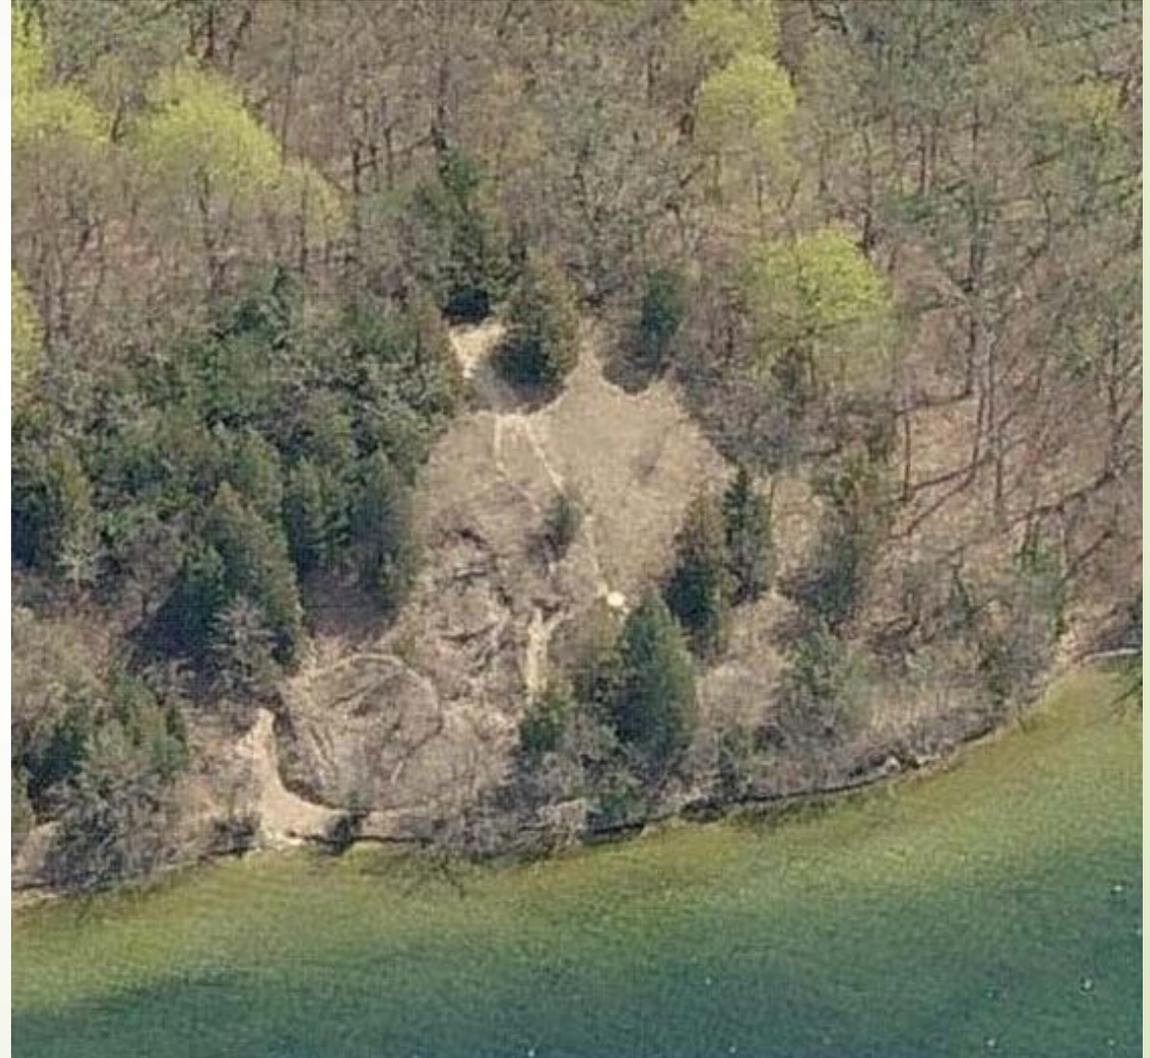
- ▶ Dry prairie has fragile vegetation and easily erodible soils.
- ▶ Cedars shade out understory exposing soil.
- ▶ No established trails so foot traffic causes erosion of vegetation and soils.
- ▶ Popular place to beach boat and hike to top of hill for overlook.

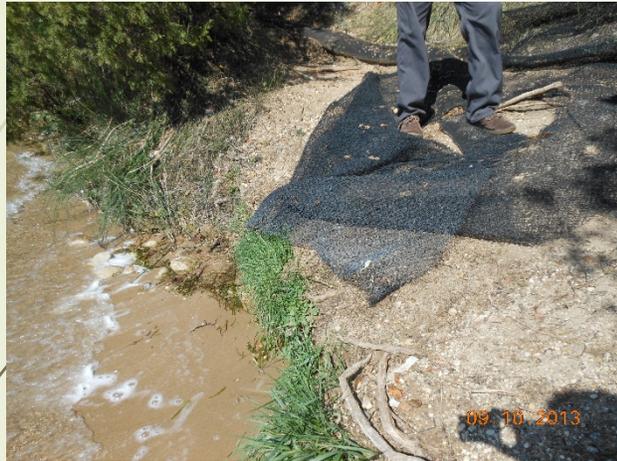
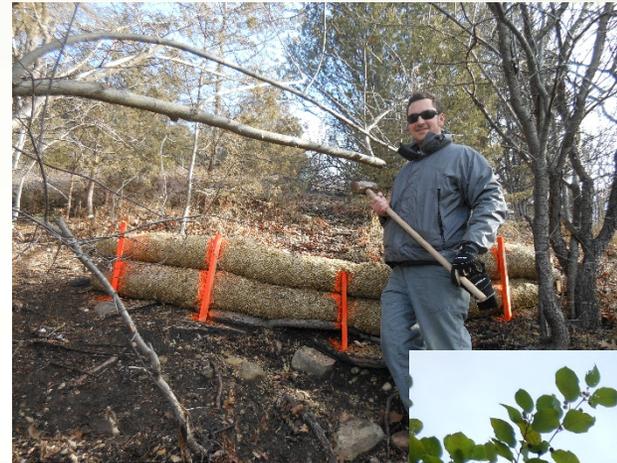
09.10.2013

Straw wattles temporarily installed to keep sediment from lake.

Beach forming from years of severe sediment erosion.

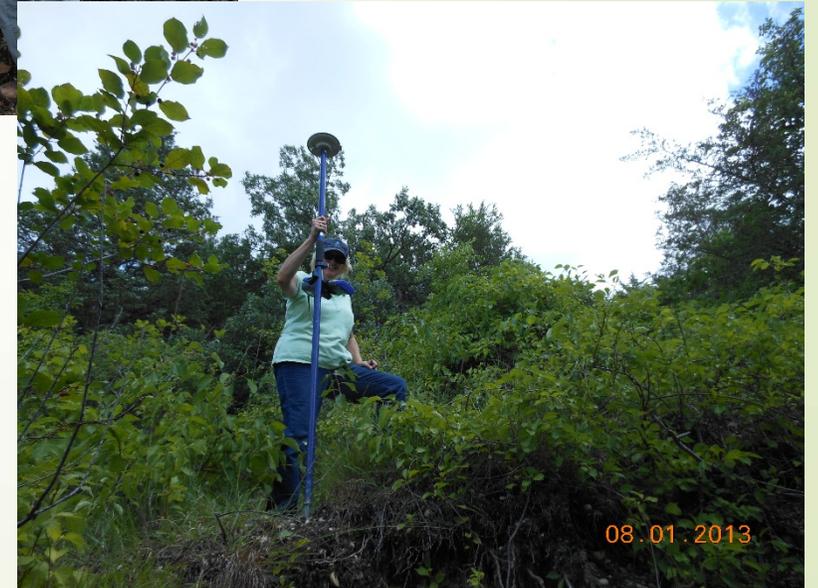
08.01.2013

Site surveyed to map location and size of gullies.

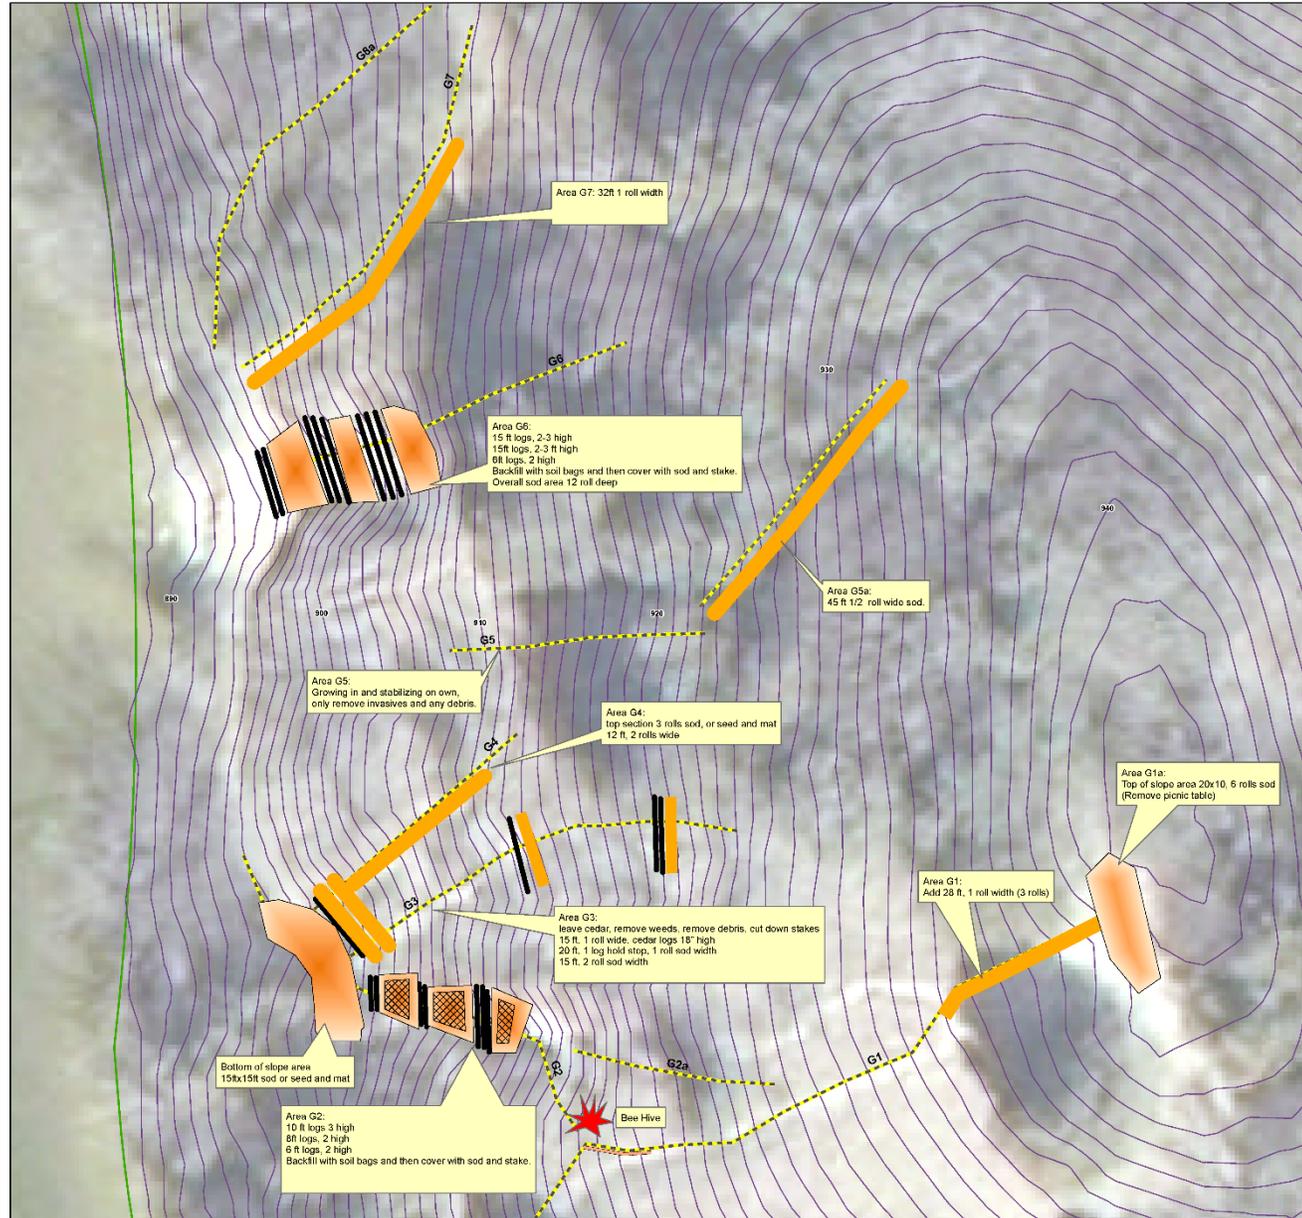
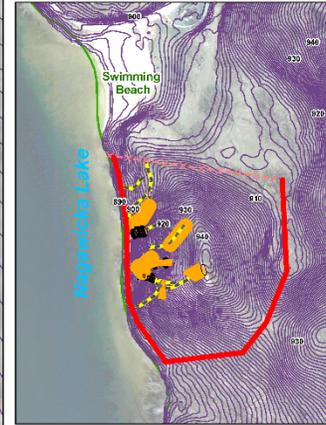
## NAGA-WAUKEE PARK Hillside Erosion Restoration Phase 2

Overall Site View for Additional Fencing

- Soil Bags (under Prairie Sod)
- Cedar Log
- Prairie Sod Area
- Prairie Sod Strip
- 10' Contours
- 1' Contours
- Gullies

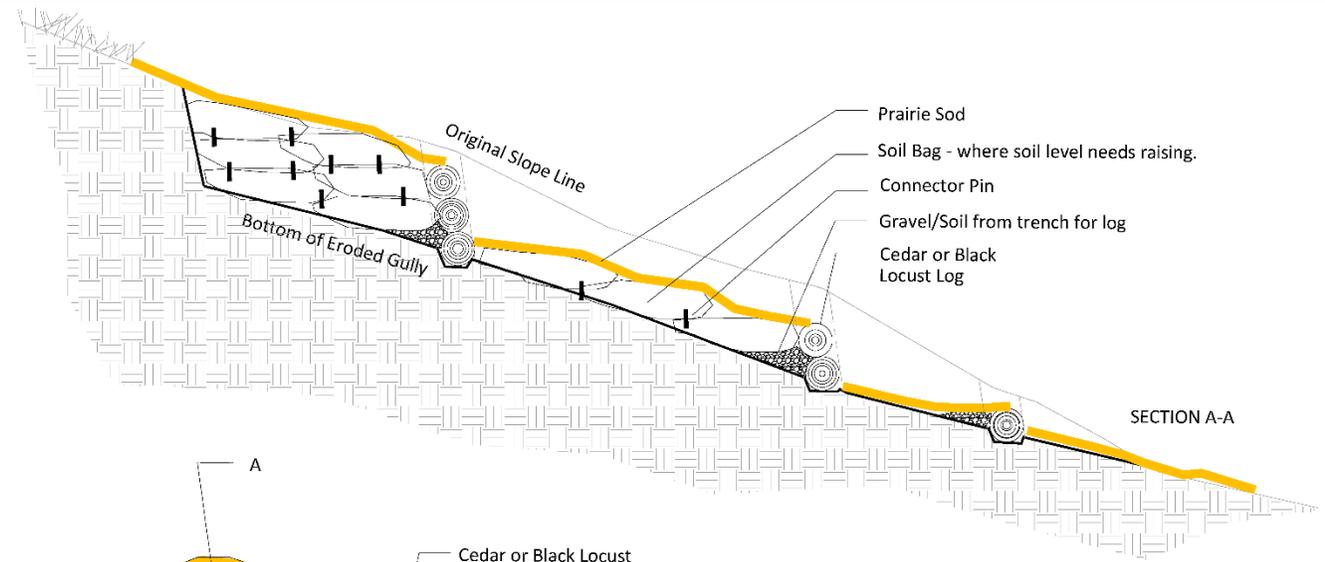
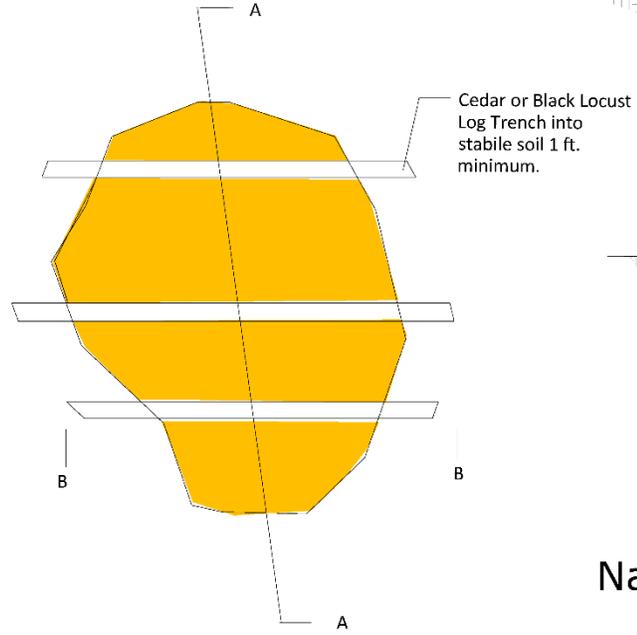
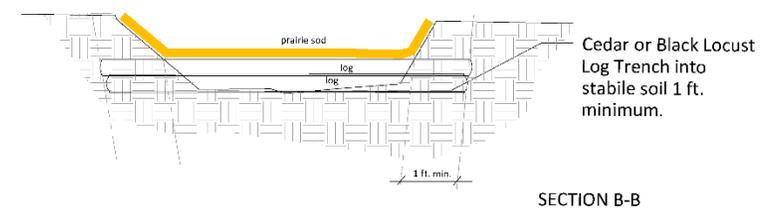
Naga-Waukeee Park Slope Restoration Details

# Detail designed for filling deep gullies.

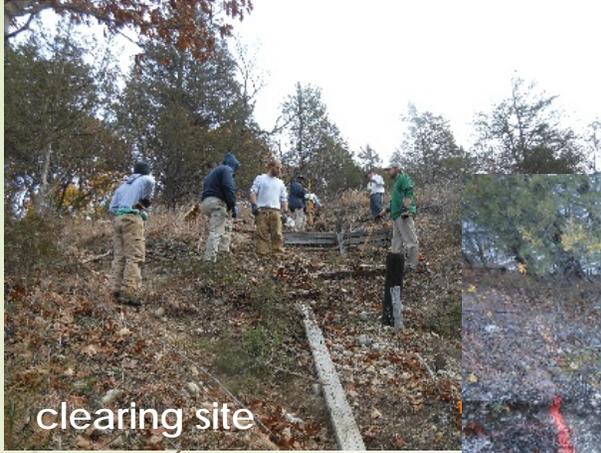
clearing site

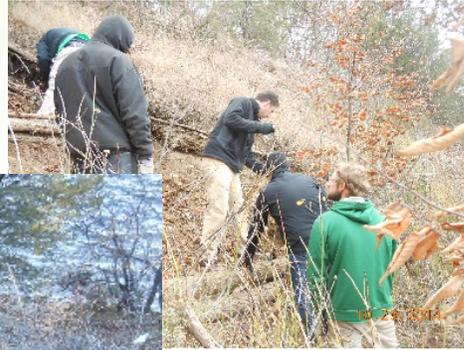
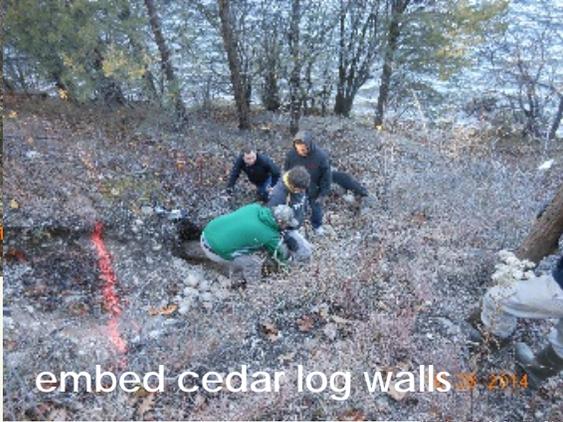
embed cedar log walls 10/21/2014

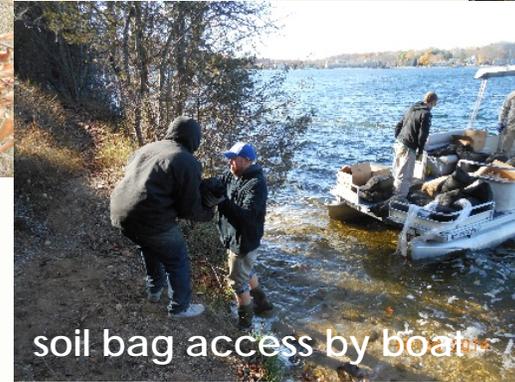
soil bag access by boat

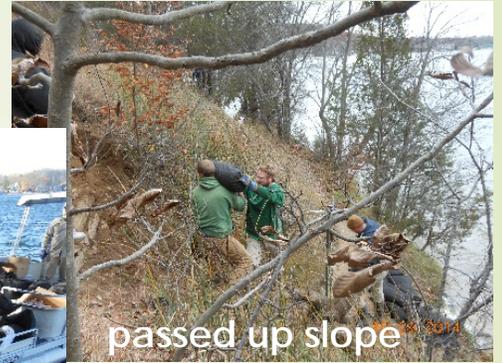
passed up slope 10/21/2014

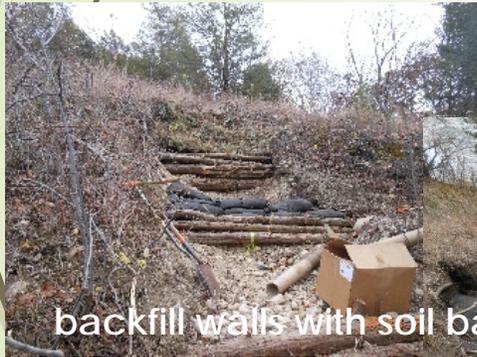
backfill walls with soil bags

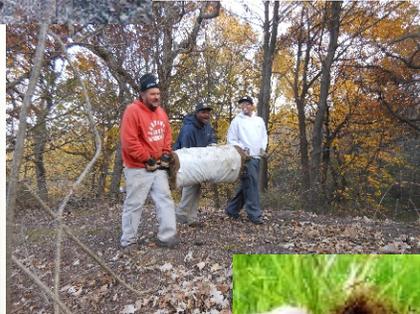
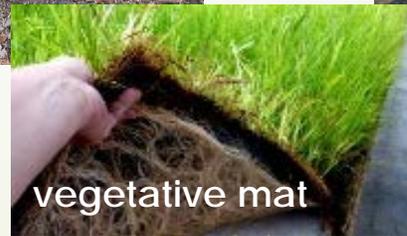
vegetative mat

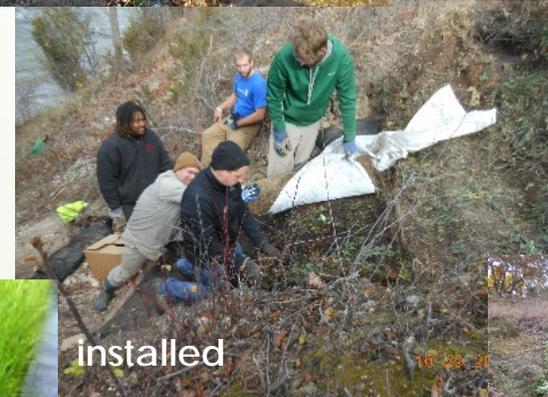
installed 10/23/2014

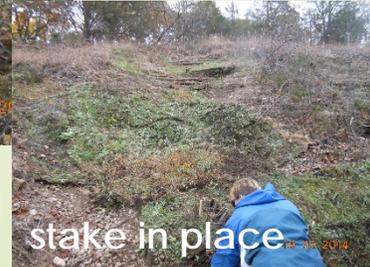
stake in place 10/23/2014

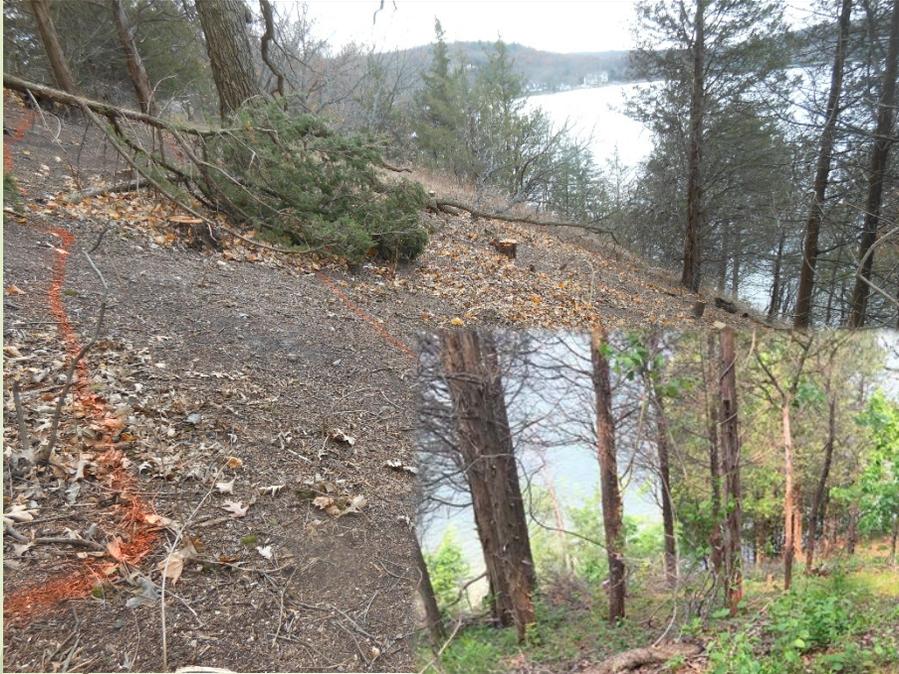
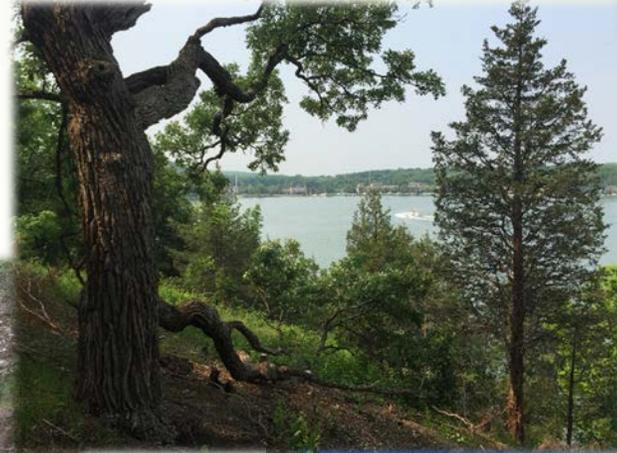
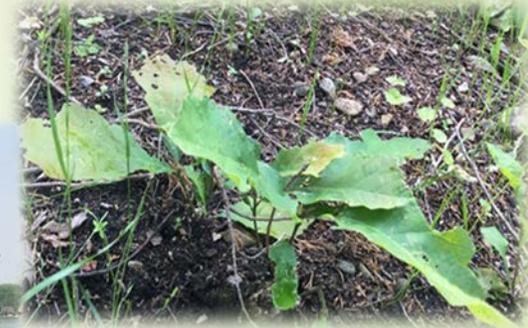
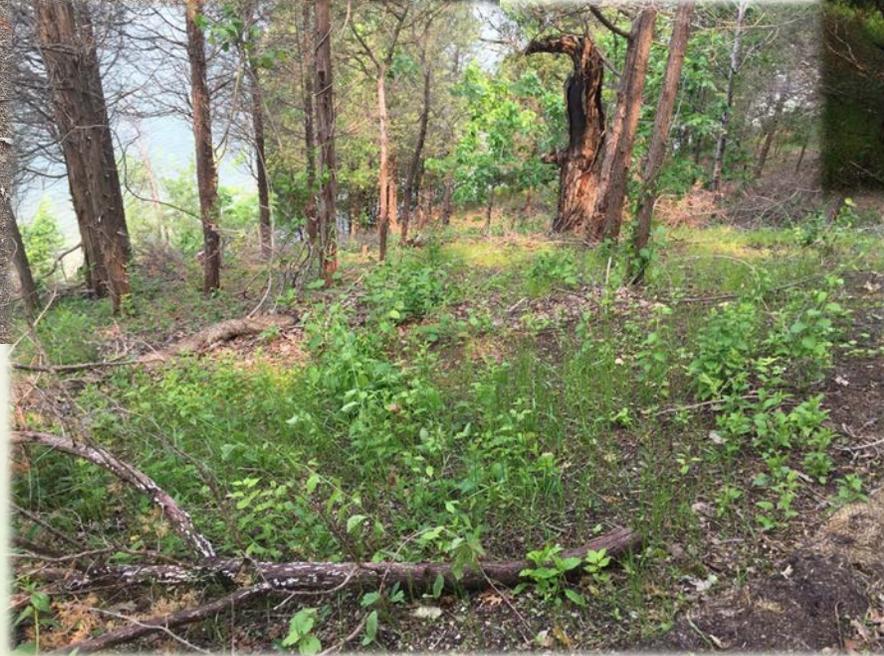
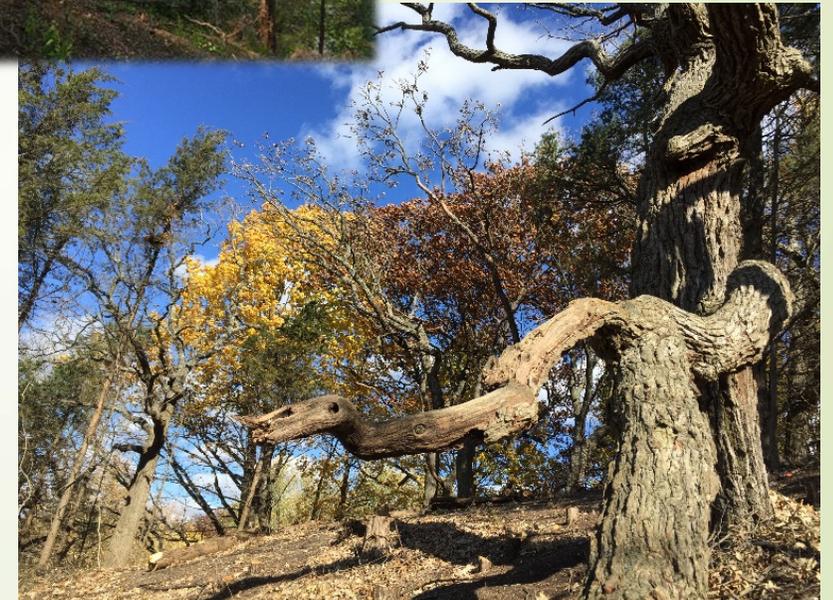
# Cedar Clearing

to promote re-vegetation of ground layer dry prairie

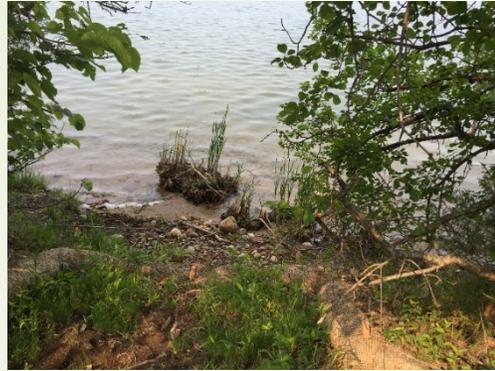
Shoreline restoration needed.

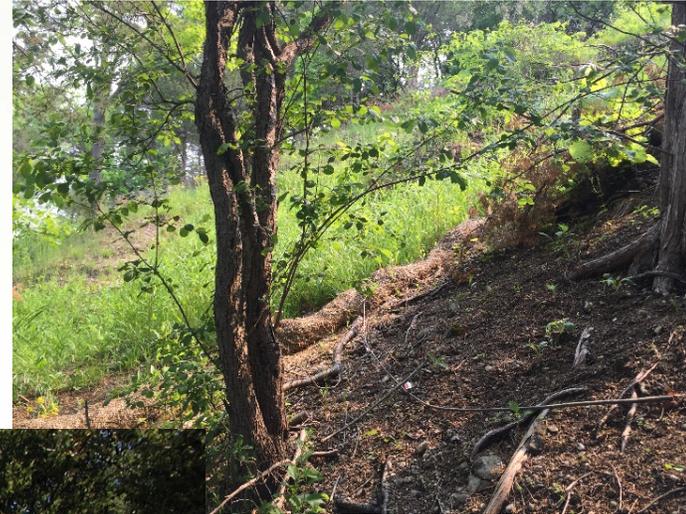
Vegetated remaining open soil areas on slope in fall of 2015.

Remove invasive Norway Maples (maybe) from back of hill. Hillside seeded in fall 2015 to establish ground layer vegetation again.
